# Strategic Replacement of 220 kV Cable at Taranaki Combined Cycle Station

Chin Yit Choo  
Contact Energy  
Auckland, New Zealand

Dr Frank Anthony Auditoré  
LineTech Consulting  
Hamilton, New Zealand

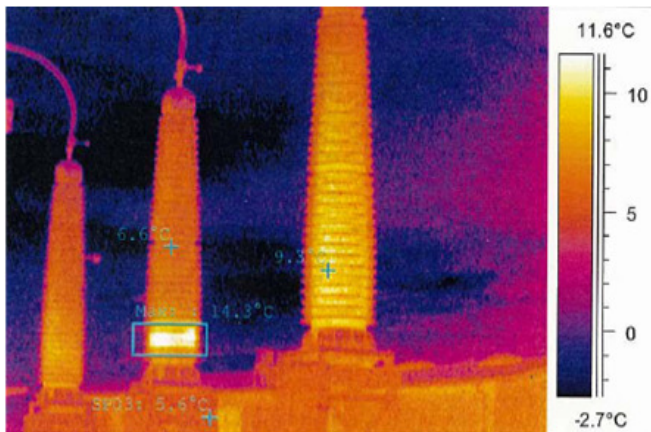
On 7 April 2008, an abnormal temperature distribution on the yellow phase 220kV outdoor sealing end cable located within the Taranaki Combined Cycle (TCC) Power Station switchyard was recorded. The survey was carried out using a thermal imaging camera as part of the condition monitoring program. The result showed 10 degrees Celcius rise over the ambient temperature at that time as shown in Figure 3. The area of concern is generally known to be a high electrical stressed area and is common that the porcelain within this area to be a number of degrees higher than the porcelain near the top. In this case the yellow phase stands up compared to the other two phases which instigated further assessments and analysis.

Figure 3: Temperature Rise On Yellow Phase 220kV Sealing End Cable

An investigation of the abnormal heating revealed a buildup of pressure in the yellow and blue phase of the cable sealing ends. Partial discharge results revealed that an abnormal level of activity was detected on the yellow phase when compared to red and blue phases.

Following the tests that were undertaken, the yellow phase cable termination bushing was dismantled at the TCC end of the cable. A constant stream of gas bubbles were seen to escape between the cable semiconductor and the lead sheath. The findings concluded that the sealing ends were in good condition other than the gas entering through the base seal. The source of gas buildup was from the cable. This was later confirmed during the decommissioning when the cable was “spiked”. Immediately after “spiking” gas expelled for approximately 15 seconds. The partial discharge testing indicated electrical activity within the cable system which would have been fatal to the installation over time.

The cable was returned to service and a pressure transmitter was installed in the base plate of the yellow phase termination. The gas pressure in the termination increased again over time indicating that the gas from the cable had again escaped through the cable seal. In theory, if the pressure in the cable is greater than the pressure in the sealing end, this could damage the bottom seal causing gas to leak into the sealing end as illustrated in Figure 4 [1]. As indicated, the gas bubbles could

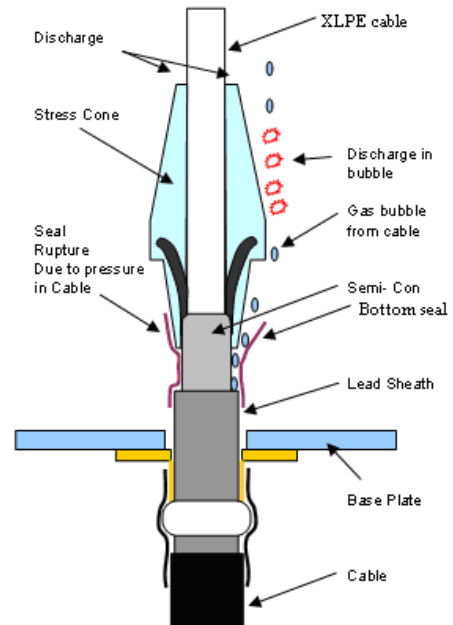
cause discharging – the possible reason for partial discharging. The repeated buildup of gas pressure led to in-house discussions regarding risk assessments and mitigation measures.

Figure 4: Cable Sealing End Cross Section [1]

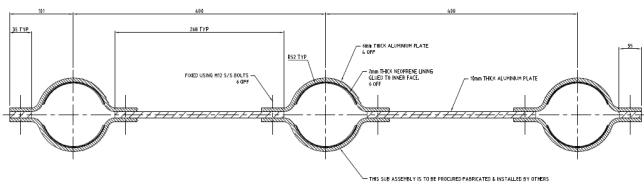
The principle of the semi flexible installation is that the cable is allowed a small amount of distributed lateral movement to allow for thermal expansion. In addition, there must be slight movement allowed for the underlying bridge support. To achieve the former the cable was waved in a sinusoidal pattern and cable cleats placed at the 0°, 180° and 360° of the waveform. Cleats were allowed to move in the lateral amplitude of the waveform. In addition to cable cleats, short-circuit straps were installed at mid span positions between cable cleats. These were installed to accommodate the lateral repulsive forces experienced on the outer cables from the symmetrical short circuit through fault current. A section of the short-circuit straps is illustrated in Figure 8. Teflon plates were installed between the short-circuit straps and the metal supports to prevent wear of the galvanized metal sections.

Figure 8: Section of Short-Circuit Strap

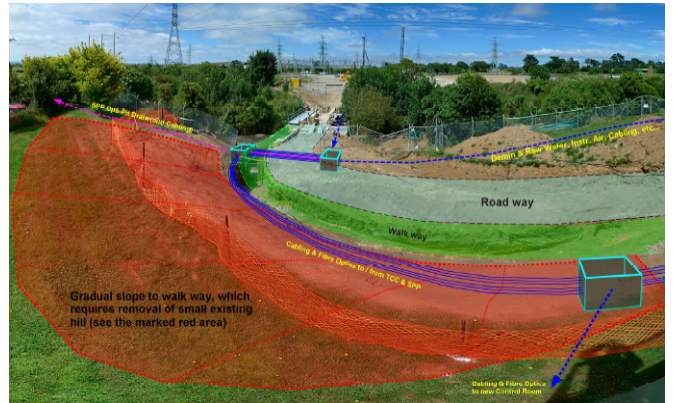
The extension of the concrete bridge facilitated a service road to be constructed across it as illustrated in Figure 9. This provision required that the cable be temporarily buried at a depth deeper than the original design. This was a temporary requirement until the surrounding area near the bridge was excavated to the actual road level.

Figure 9: Provision for Service Road Across Bridge

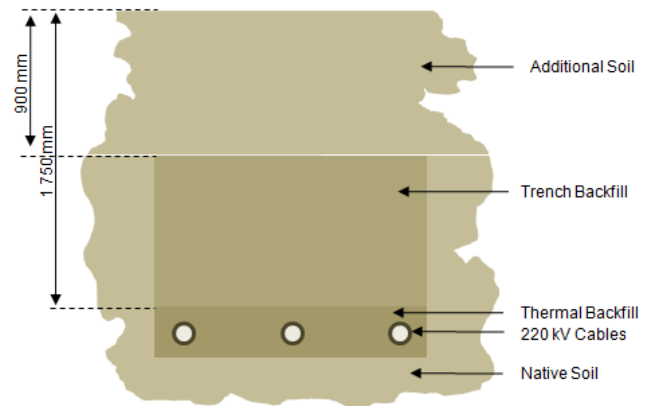
With the initial cable design parameters and the tested soil resistivities, the need to increase the existing ground level above the 220 kV cable in the area of the steel bridge by 900 mm was technically acceptable. This was based on a calculated ampacity of 1 307 A with the actual requirement being only 1 102 A. At this increased ground level the conductor temperature is expected to increase from 50°C to 70°C. This increase is 20°C below the acceptable maximum operating conductor temperature of 90°C.

Figure 10: Increasing the Burying Depth

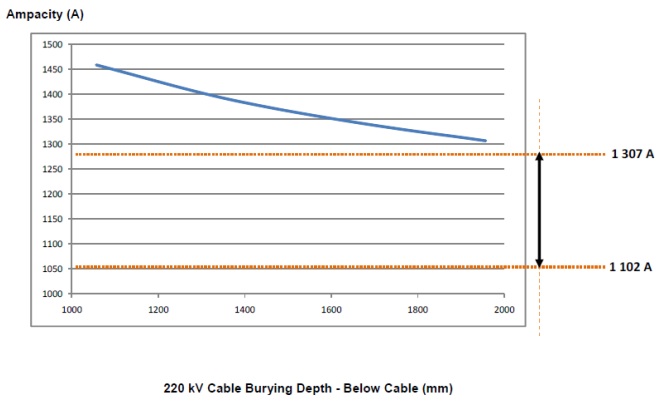
Figure 11: Effect of Increasing Burying Depth [3]
